# **Evaluation Of Cavitation Damage Resistant Coatings For Use On Naval Structures**

**Presented by:  
Daniel Metrey  
Composite Materials Division  
Applied Research Laboratory  
The Pennsylvania State University**

**Presented At:  
2002 NCMS CTMA Symposium  
Omni Jacksonville Hotel  
Jacksonville, FL  
16 April 2002**

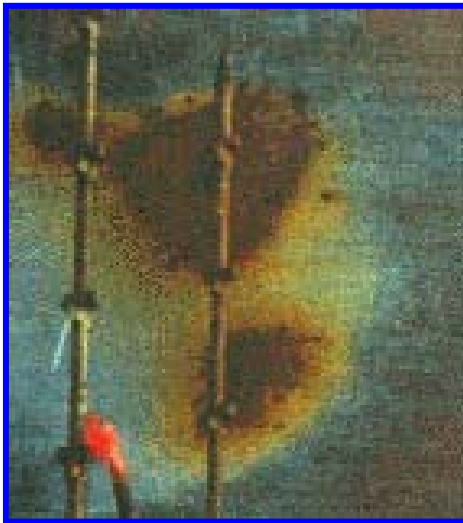
Large Areas of Erosion on a Naval Structure

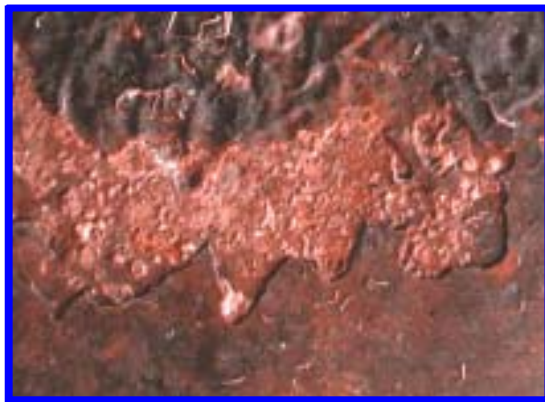
Close-up View Of Damage Showing Exposure Of Base Steel

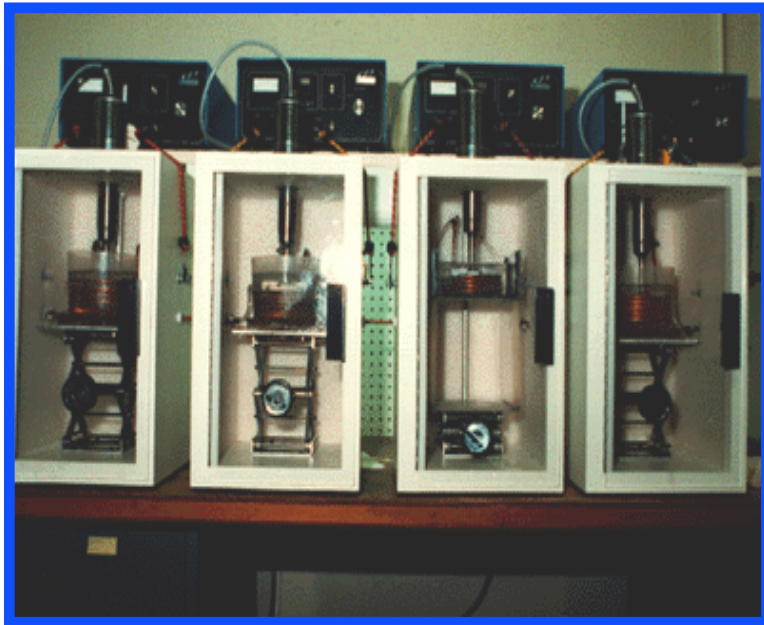
**Ultrasonic Screening Fixtures  
Modified ASTM G32-85**

- Screening test - Modified ASTM method G-32-85
- Water tunnel test – ARL Penn State's 1.5-inch Ultra High Speed Cavitation Tunnel

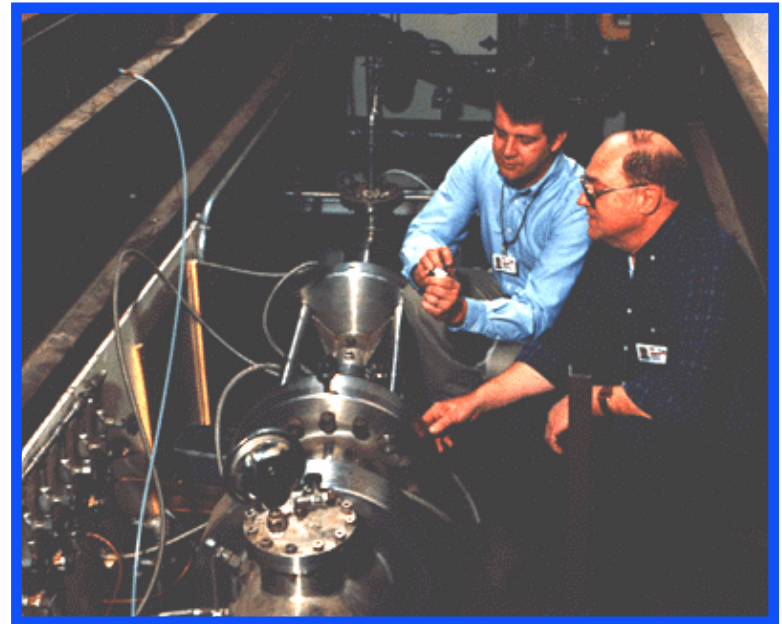
**1.5-inch Ultra High Speed  
Water Tunnel**

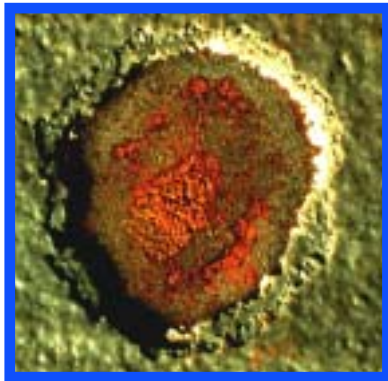
**Extensive Damage**

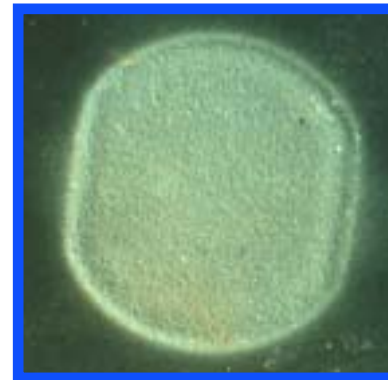
**Moderate Damage**

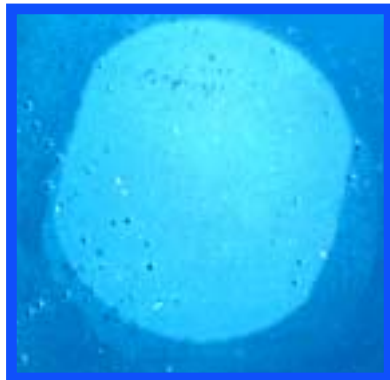
**Low Damage**

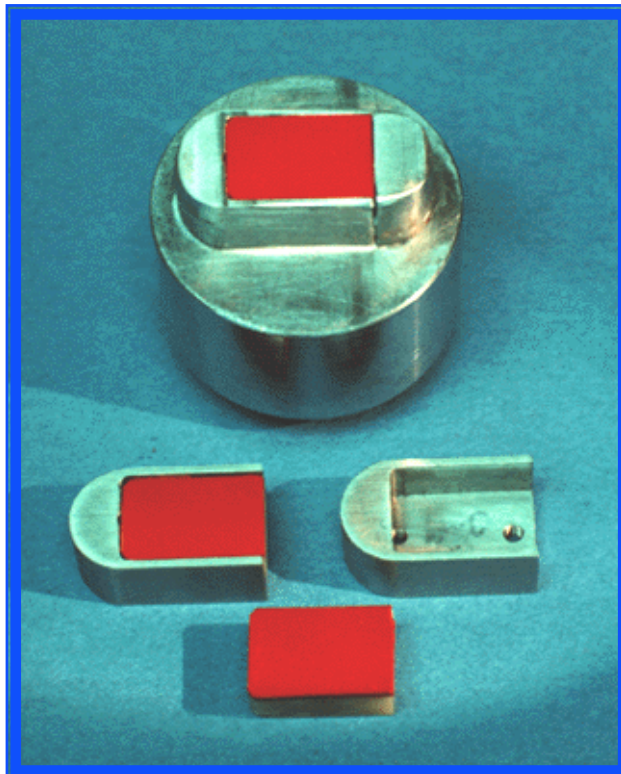
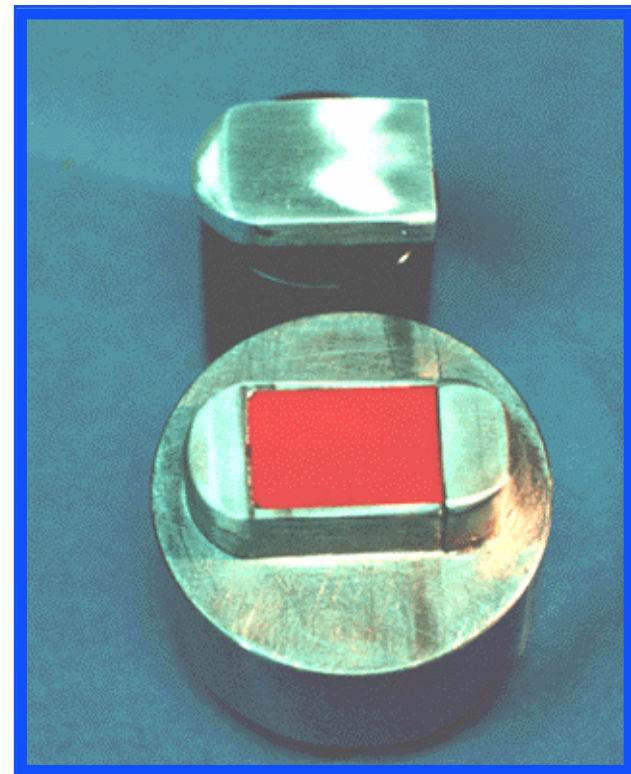
## 1.5-inch Ultra High Speed Water Tunnel Test Specimen Configuration

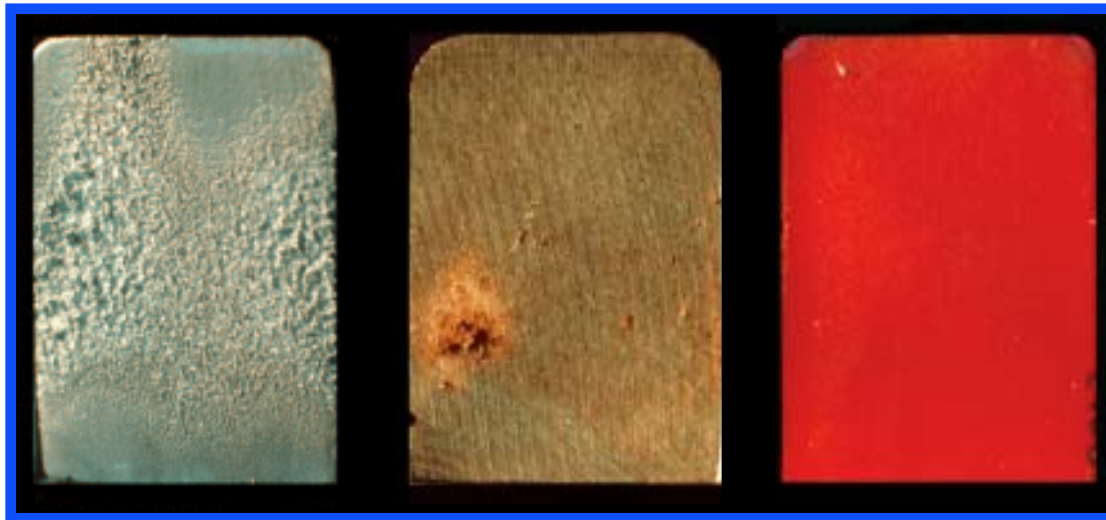
**Aluminum  
(2.5 Hrs)  
Extensive  
Erosion**

**NiAl Bronze  
(20 Hrs)  
Moderate  
Erosion**

**Polyurethane  
(20 hrs)  
No  
Erosion**

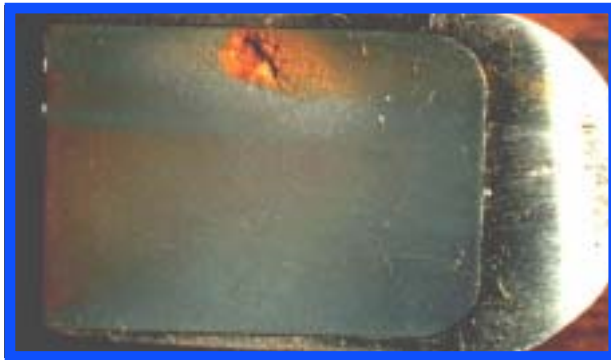
**Erosive Failure**

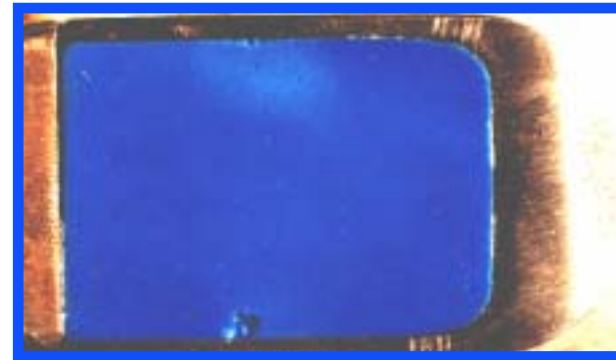
**Pitting Failure**

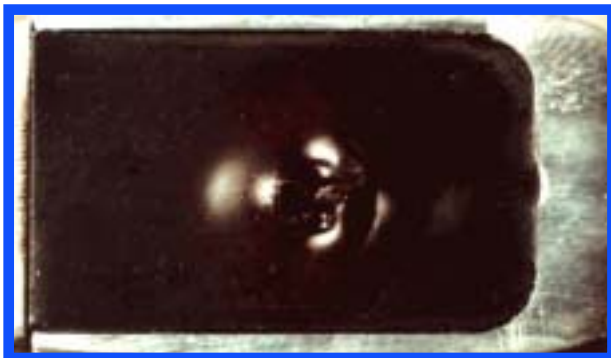
**Dynamic Failure**

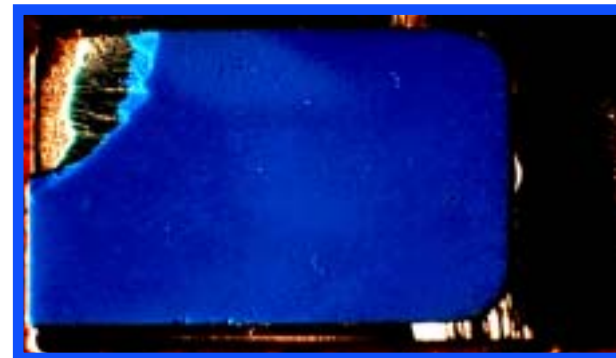
**Adhesive Failure**

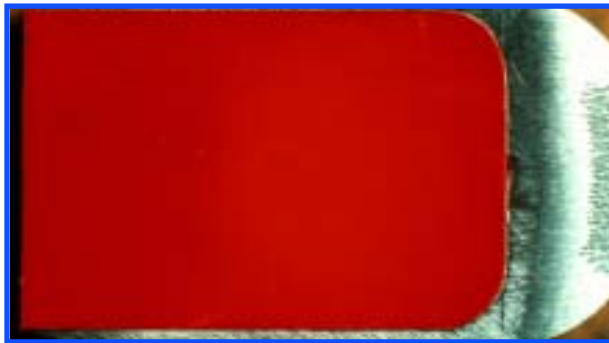
**Cast Sample**

- Air entrapment
- Defects
- Thickness
- Uniformity
- Adhesion

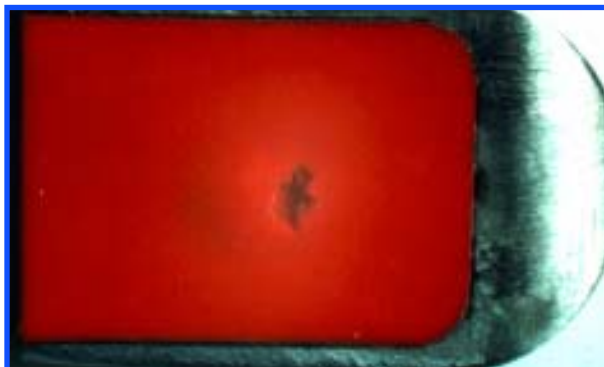
**Sprayed Sample**
